Re: November 2012 Monthly Progress Report  
Administrative Settlement Agreement and Order on Consent for Removal Action  
U.S. EPA Region 10 Docket No. CERCLA 10-2009-0255  
Gasco Sediments Site within the Portland Harbor Superfund Site

Attachment A      Monthly Visual Monitoring Report for Pilot Cap Vicinity

## Visual Observations Log Form

Project Name: NW Natural – Gasco

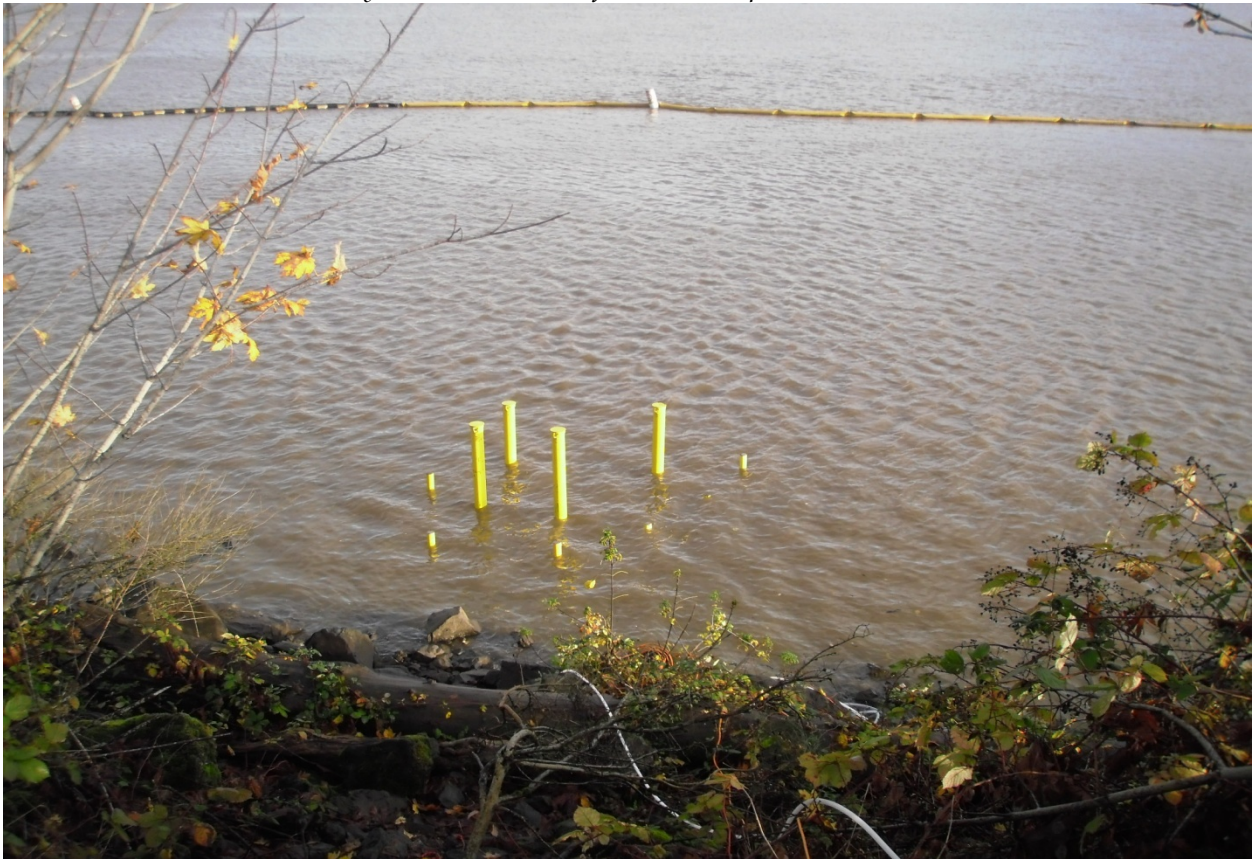
Observations of Erosion/Deposition: No erosion/deposition is evident along the shoreline. The shoreward extent of the cap was not visible due to high river water elevation; and the extents of the organoclay mat material were also submerged. (Photo 1).

Photo 1 — *River level currently above the extent of sediment cap (11/21/12):*

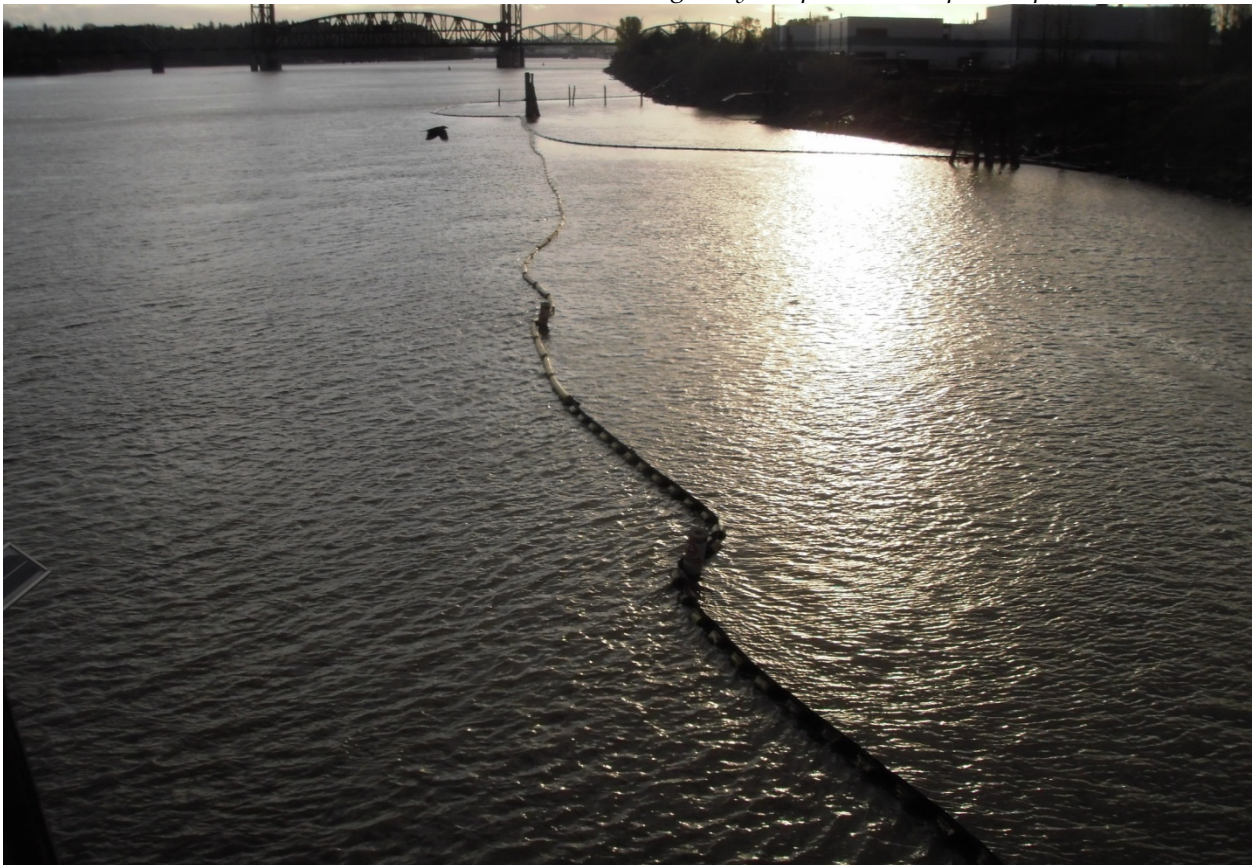
Observations of Long-term Controls (i.e., oil booms, organo-clay mat, etc.) During the observation, the Fuel and Marine Marketing (FAMM) containment boom was placed across the cap area, between the upriver corner of the ship dock and the wooden dolphin (near the upriver extent of the site and near the Siltronic Corporation outfall). Buoys that identify the cap area to mariners are in place as installed. The position of the FAMM oil boom, warning buoys, and a general overview of the site shoreline is shown in Photo 2.

Photo 2 — *FAMM oil boom shown and mariner warning buoys in place across pilot cap area. 11/21/12):*

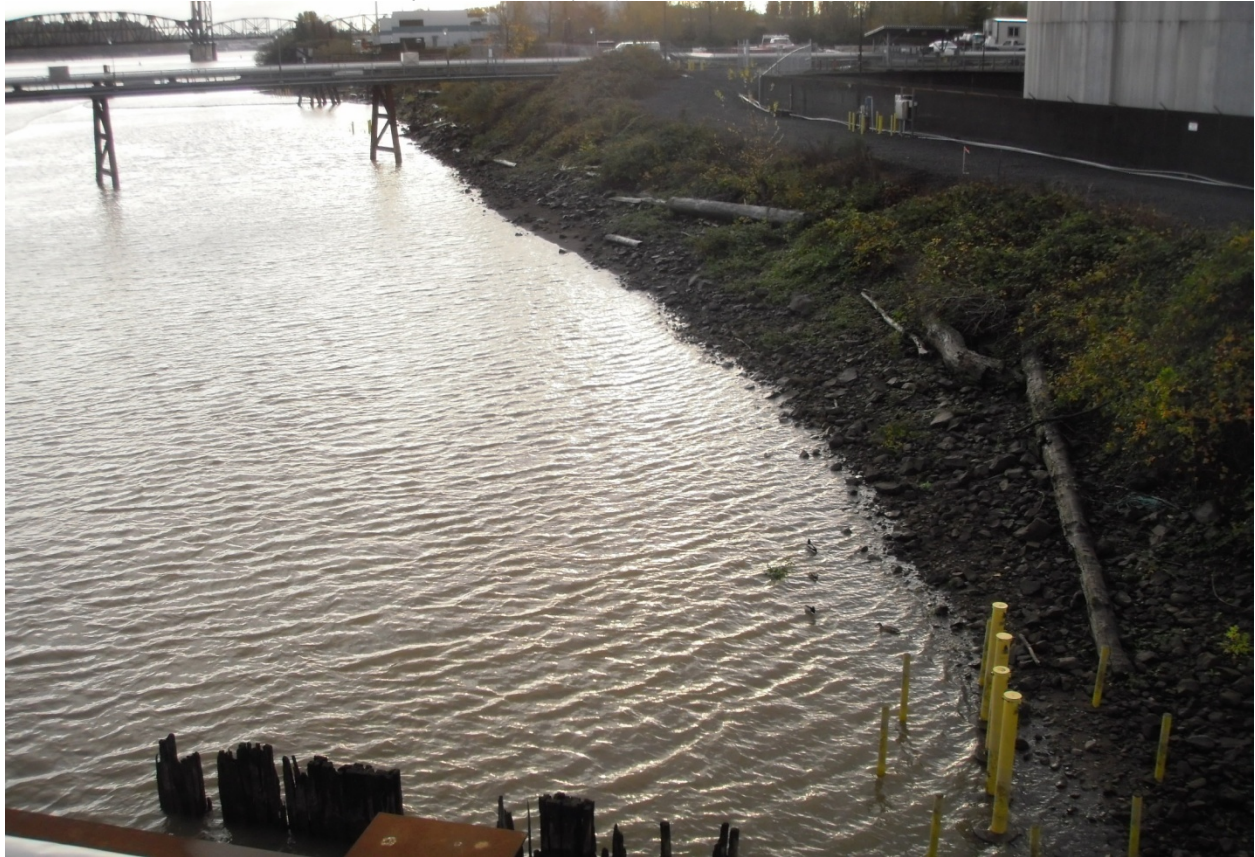
Other Comments: No sheen is evident in or around the cap area. Photo 3 shows the water surface and shoreline immediately downriver of the sediment cap.

Photo 3 — *Conditions immediately downriver of cap area (11/21/12):*
